Grand Teton National Park

Moose-Wilson Corridor Road Safety Audit

Conducted September 9-11, 2013

February 13, 2014

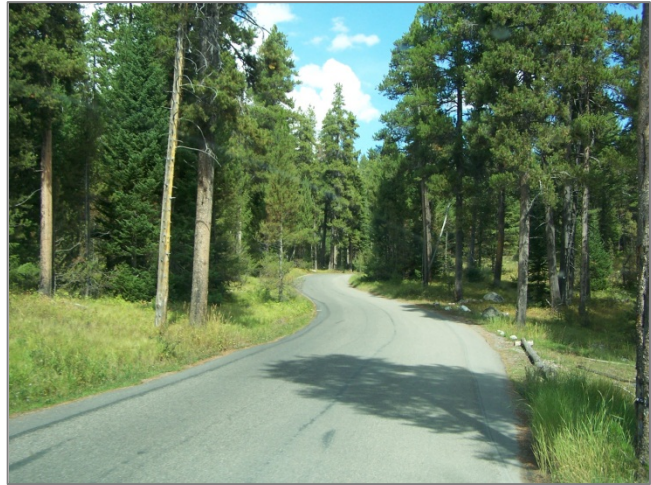
Figure 3. Moose-Wilson Road

The study area consists of the Moose-Wilson Road from the intersection with Teton Park Road in Moose to the Granite Canyon Entrance Station in the southwest corner of the Park. The road meanders through sagebrush, wetlands, and alpine and subalpine forested areas. The route was established in the late 1800s as a wagon road to local ranches and residences,⁵ and has evolved over time into a road that has about five miles of paved surface at the north end, just over one mile of gravel surface in the middle, and about one mile of paved surface at the south end. The primary intersecting roads include: the Murie Center access road, a short gravel road; the LSR Preserve entrance road, a short paved road; and the Death Canyon Road which has approximately three-quarter miles of paved surface and one mile of rough dirt surface.

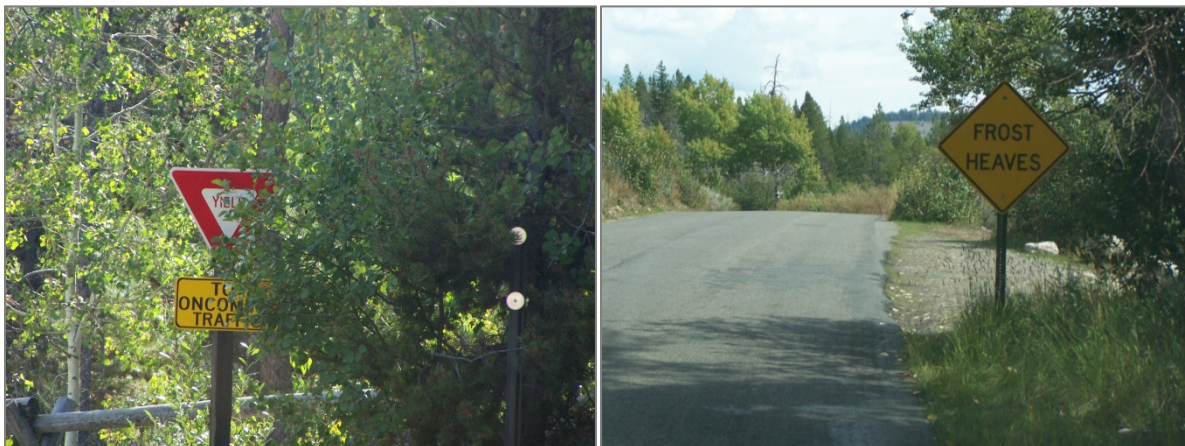
Signing on the route consists of some warning signs, guide signs, and regulatory signs. Pedestrian crossings, a single-lane bridge and some curves are signed, but there are generally few advanced warning signs. In addition, many signs are obscured by vegetation, or have inconsistent or unclear language that may not be understood by visitors.

Figure 4. Obscured and Confusing Signs

- *Improve location of signs and sign messages*
- *Trim vegetation that block signs*
- *Prepare a sign replacement plan and an assessment or management method for addressing sign retroreflectivity (according to requirements in the Manual on Uniform Traffic Control Devices [MUTCD])*
- *Provide advanced warning and additional wayfinding/guide signing*

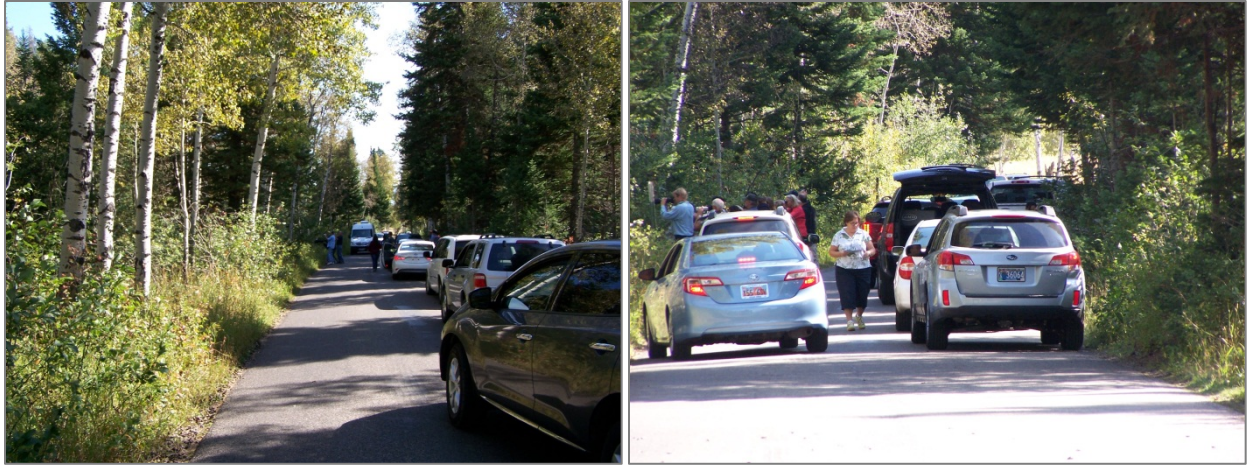
Some of the most rich and diverse wildlife habitat in the Park can be found in the Moose-Wilson Road corridor, which has led to it becoming a popular visitor destination. Grizzly bears have inhabited the corridor since 2008, and other wildlife species (including black bears, moose, elk, deer, gray wolves, coyotes, and beavers) are also present in the corridor. The closeness of food sources to the road has led to increased viewing opportunities for visitors, which causes frequent “wildlife jams” and the likelihood of unacceptable wildlife-human interactions.

Figure 5. Wildlife Jams

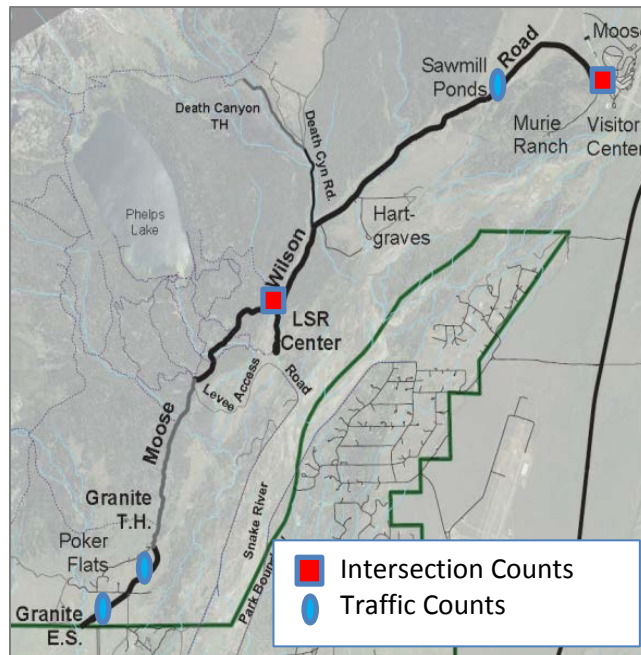
Figure 6. Traffic Count Locations

The Park initiated a traffic data collection plan in July 2013 with the Utah State University⁶ as part of a recreation ecology study of the Moose-Wilson Road corridor. Preliminary data was made available to the RSA Team and includes traffic counts and vehicle classification information at key locations along the route, along with some turning movement counts at two intersections. Figure 6 shows the locations of the preliminary traffic counts.

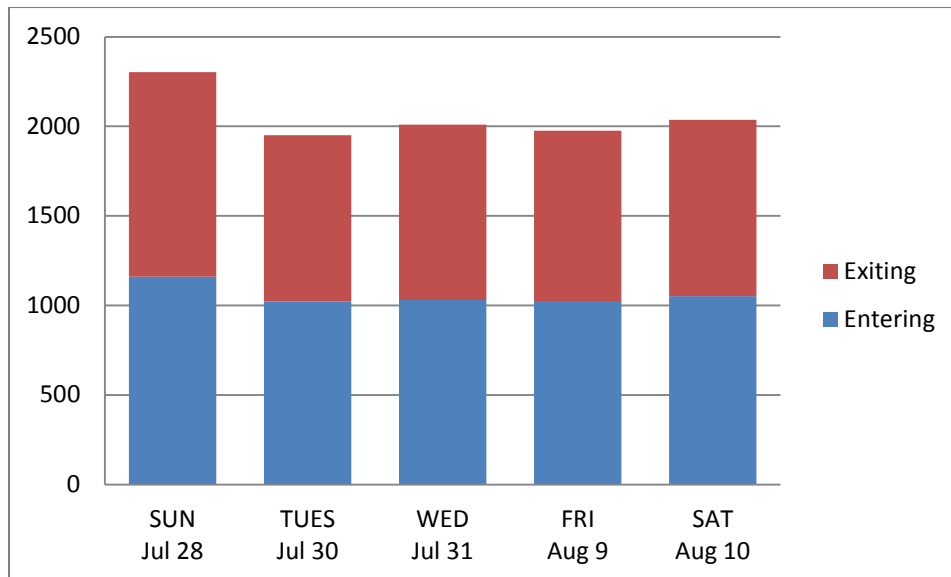
In addition to these traffic counts, seven days of vehicle counts were taken July 28-31, 2013, and August 9-11, 2013, near the Granite Canyon Entrance Station with a video system that could capture vehicle direction and bicycle presence.⁷ While two days experienced technical issues with the counters, the other five days showed the directional split of the traffic as approximately 50/50, with an almost even number of entering and exiting traffic each day (Figure 7).

Figure 7. Directional Traffic at Granite Entrance Station

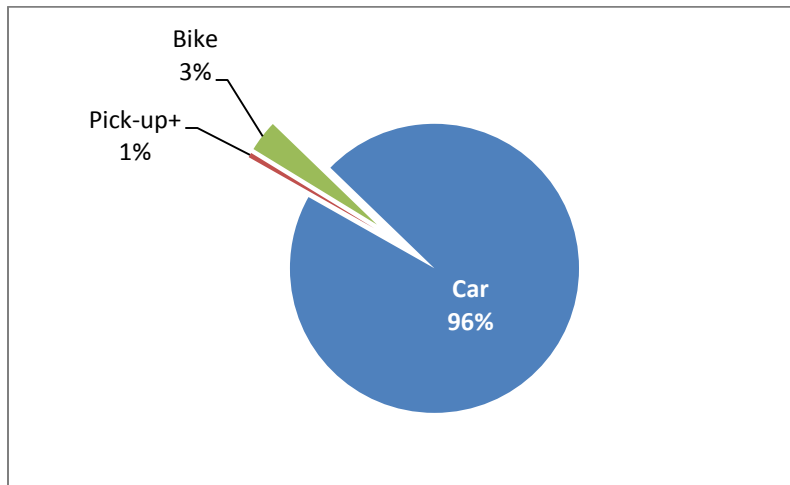
The counts taken at Granite Entrance Station also showed a distribution of 97-percent of the traffic being vehicular and 3-percent being bicyclist (Figure 8).

Figure 8. Average Distribution by Traffic Type

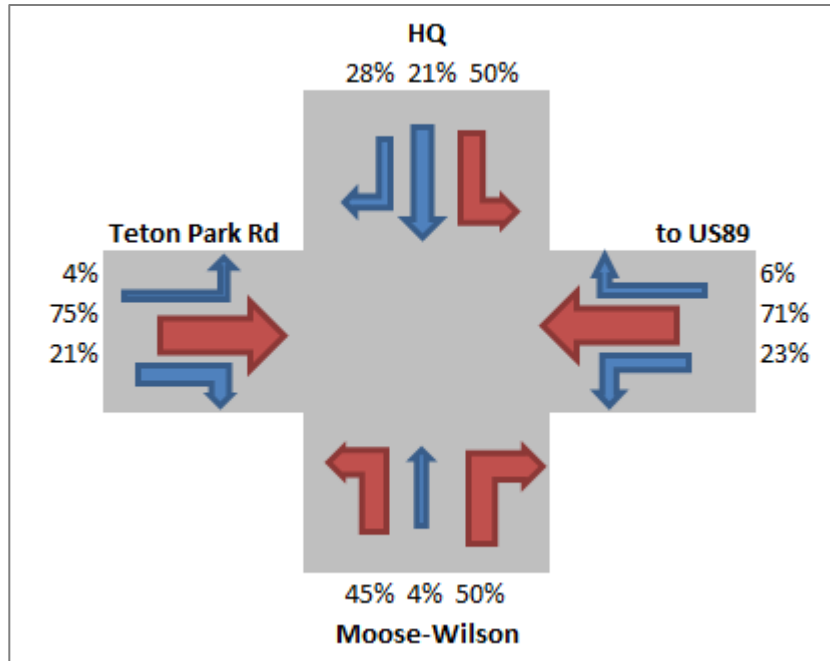
For the Moose-Wilson and Teton Park Road intersection, the dominant traffic movements overall and for the AM and PM peak hours were the through movements on Teton Park Road. Secondary traffic movements included the left turns from the Park Headquarters and the right and left turns from northbound Moose-Wilson Road onto Teton Park Road. The majority of traffic at this intersection appears to be for the through movements on Teton Park Road as visitors enter and exit the Park. Figure 9 shows the overall traffic movements for July 28, 2013, with the red arrows designating the dominant movement from each direction. Bicycle presence at the Teton Park Road intersection was less than 1-percent of the total traffic volume, with the majority of bicycles heading east toward US89 or south on Moose-Wilson Road. However, it was unknown at the time of the RSA whether the bicycles were traveling on the roadway or the pathway along Teton Park Road.

Figure 9. Moose-Wilson and Teton Park Road Intersection
(Distribution of Overall Turning Movements on July 28, 2013)

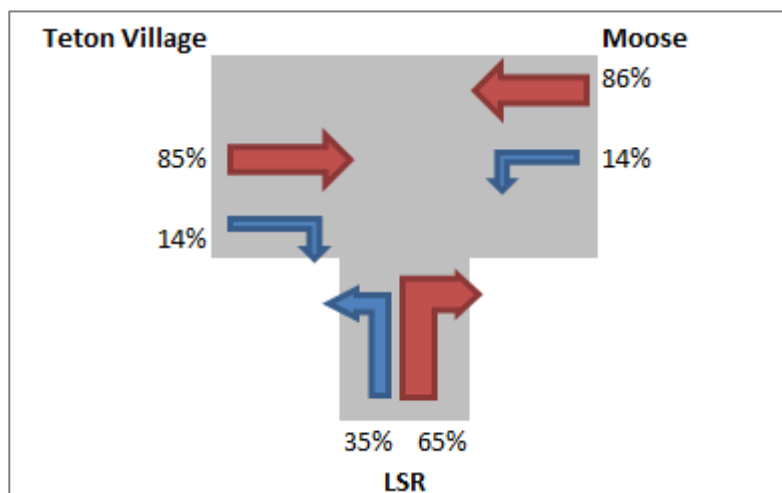
For the Moose-Wilson and LSR Preserve intersection, the predominant traffic movements overall and for the AM and PM peak hours were the through movements on Moose-Wilson Road and the right turns from the LSR Preserve onto Moose-Wilson Road. Figure 10 shows the overall traffic movements for August 10, 2013, with the red arrows designating the dominant movement from each direction. Bicycle presence at the LSR Preserve intersection was approximately 3-percent of the total traffic volume, with the majority traveling straight through in both directions on Moose-Wilson Road.

Figure 10. Moose-Wilson and LSR Preserve Intersection
(Distribution of Overall Turning Movements on August 10, 2013)

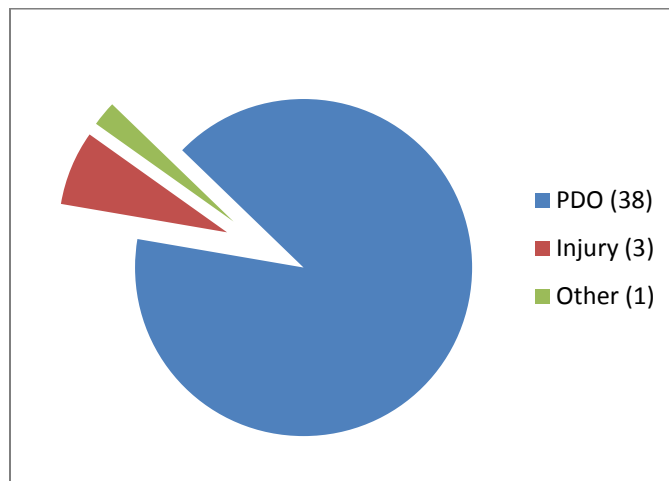
Approximately 90-percent of the crashes the Park provided information on were property damage only (PDO), with the remaining 10-percent consisting of three injury crashes (two involving bicyclists) and a pedestrian-involved “Other” incident with no reported injuries (Figure 11). The bicycle-related incidents were both bike vs. vehicle during peak visitation months and included one where a cyclist ran into a parked dump truck; both incidents resulted in minor injuries to the cyclists.

Figure 11. Distribution by Crash Type
(Number of crashes shown in parenthesis.)

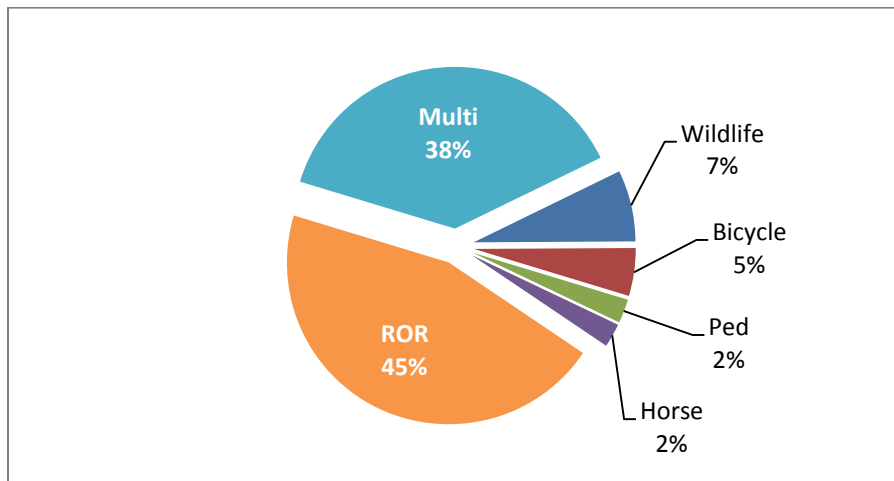
Almost half of the crashes on Moose-Wilson Road involved single vehicles in run-off-road (ROR, 19 crashes) incidents and just over a third involved multiple vehicles (Multi, 16 crashes), as shown in Figure 12. The other reported incidents included collisions with wildlife (usually elk), bicyclists, a pedestrian, and an equestrian.

Figure 12. Crash Distribution by Collision Type

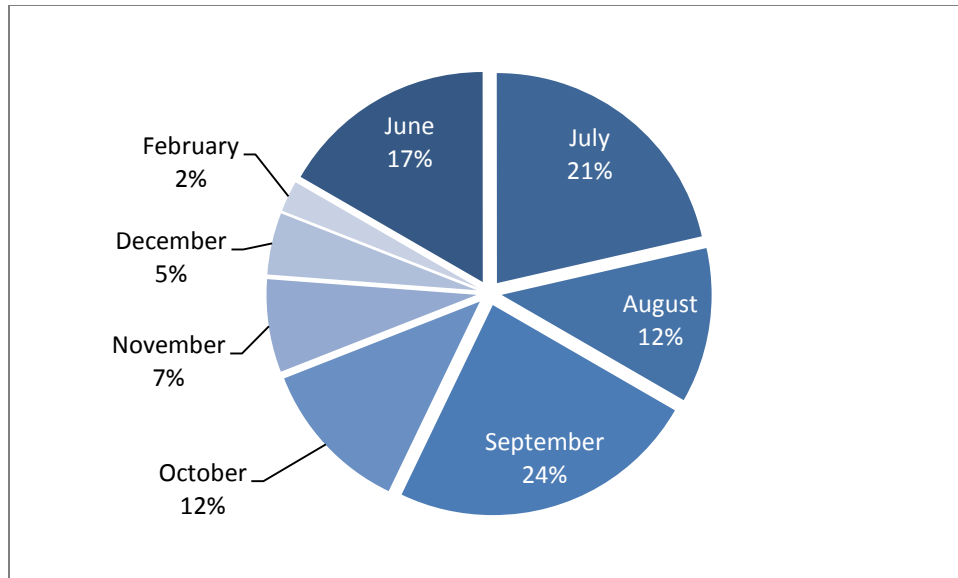
The majority of the reported crashes happened between June and September, which are the historical peak visitation months of any year,⁹ with about 26-percent of the crashes occurring during the other months (Figure 13). Almost half of that 26-percent occurred during October when the road is still open to traffic, while the remaining number of crashes occurred between November and May when the section between the Death Canyon Road intersection and the Granite Trailhead parking area is generally closed to motorized traffic.

Figure 13. Crash Distribution by Month

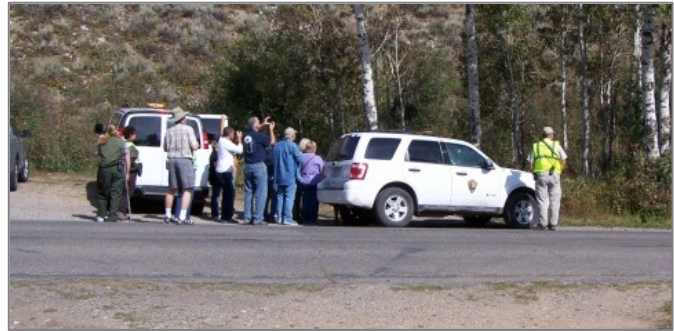
Figure 14. Park staff responding to "wildlife jam."

If recent traffic trends continue, the Moose-Wilson Road corridor will attract more visitors, and parking overflow and “wildlife jams” will become more prevalent. Currently the northbound vehicles must enter the Park through a fee station at the Granite Canyon Entrance, but southbound traffic is not required to enter through any control point. Therefore, northbound travelers may be informed by park staff of wildlife-viewing traffic jams, full parking areas, or other road conditions, but southbound travelers may know little about what lies ahead in the corridor. Other parks, such as Zion and Grand Canyon, have implemented measures to control where, when, or how visitors have access to certain park areas through limited transportation options, restricted directional movements (like changing operations from two-way to one-way), or restrictions based on season, time of day, or day of week. For example, the Zion National Park Shuttle System¹⁰ was implemented in 2000 “to eliminate traffic and parking problems, protect vegetation, and restore tranquility to Zion Canyon.” Private vehicles are allowed access to the canyon road during the non-peak months (November through March), but are banned from the road when the shuttle system operates during peak visitation months. Bicyclists are allowed on a shared pathway and all roads in the park, but can only be on the Zion Canyon Scenic Drive when the shuttles are operating.

- *Provide additional information and orientation opportunities to visitors entering from the North (e.g., kiosks, entrance station, signs, etc.)*
- *Restrict access based on visitor volume, permit system or other methods (wildlife migration, time of day, etc.)*
- *Develop visitor information systems (e.g., map, website, radio, message boards) with typical driving times and road conditions*
- *Improve pullout frequency, location, size, and surfacing*

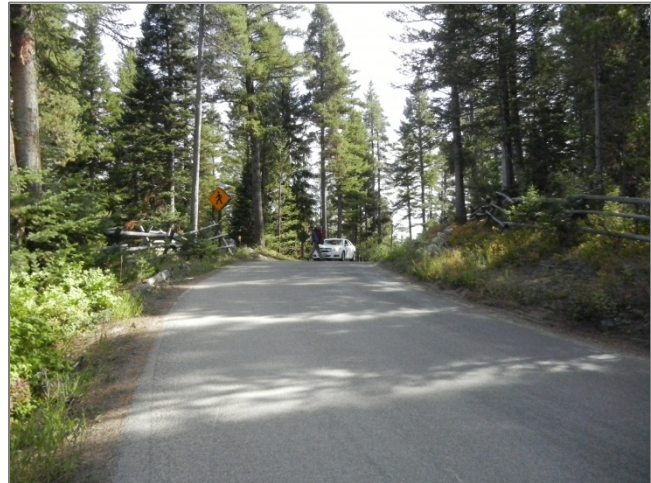
There are pedestrian crossings where the warning signs are situated right at the crossing instead of being in advance of the crossing. These crossings also have stone and colored concrete in the roadway which can be very difficult to distinguish under certain light conditions. Anecdotally, there are an increasing number of cyclists on the road due to the completion of the shared-use Pathways within and just outside the Park boundaries. However, there are few signs warning drivers about the presence of cyclists, especially where the road narrows. In addition, there are recently developed horse trail crossings which have no signs or markings at all.

Figure 15. Pedestrian Trail Crossing

- *Provide painted pavement markings at pedestrian crossings and intersections*
- *Provide duplicate information and signing at each end of the corridor regarding conditions and/or restrictions*

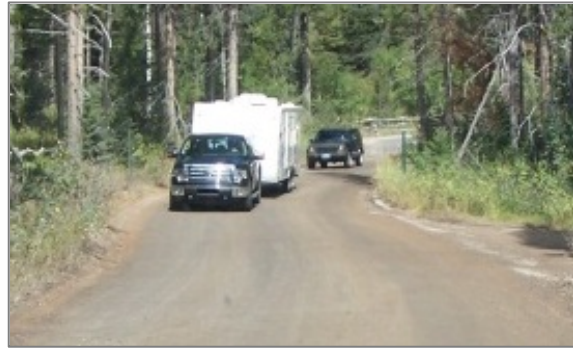
Drivers in this corridor are a mix of local residents, Park visitors, and commercial entities. Users of the corridor encounter numerous conflicts between other traffic types (e.g., bicycles, pedestrians, and equestrians), wildlife, and several drivers who are unsure about their location. The RSA team witnessed many drivers stopping in the middle of the road and exiting their vehicles to take photos of wildlife; asking for directions to Moose or Teton Village; driving oversized vehicles despite the presence of restriction signs; and passing on blind horizontal and vertical curves. Park staff have also witnessed these confused visitors and conflicts, and noted that some oversized vehicles access the Moose-Wilson Road through the Granite Canyon Entrance Station during hours when the station isn't manned.

Figure 16. Oversized Vehicle

- *Add wayfinding signs*
- *Improve information on vehicle restrictions and provide a uniform message on signs*
- *Provide designated space at the north end for oversized vehicles to turnaround*
- *Increase enforcement of traffic regulations in corridor*

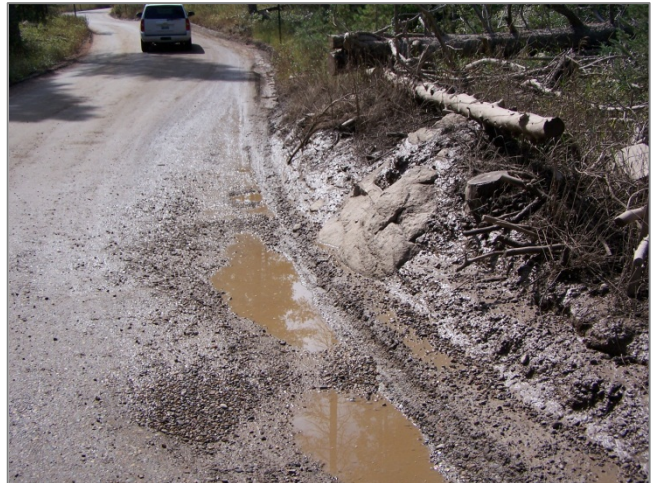
The middle section of Moose-Wilson Road is unpaved and drainage and ponding issues occur in many locations, along with potholes in many curves. As the route has developed since the 1800s, some portions have been paved while the middle section has remained unpaved. Maintenance in this unpaved section has been focused on smooth surfacing rather than building up a road template, so blading operations in some areas has created a sunken road grade where the native soil is higher than the road. Water runoff in these sunken locations has no escape and creates puddles and potholes due to rain events. Besides being a maintenance issue, the puddles and potholes cause some safety concerns due to drivers veering into oncoming traffic to avoid hitting the potholes. Another observation in the unpaved section was the number of downed trees and stumps in close proximity to the road. It is unknown whether the vegetation in this section is being compromised by gravel maintenance practices, but the stumps greater than 4-inches in height at or near the edge of the roadway can be a hazard for motorists and cyclists.

Figure 17. Unpaved Roadway and Roadside Hazards

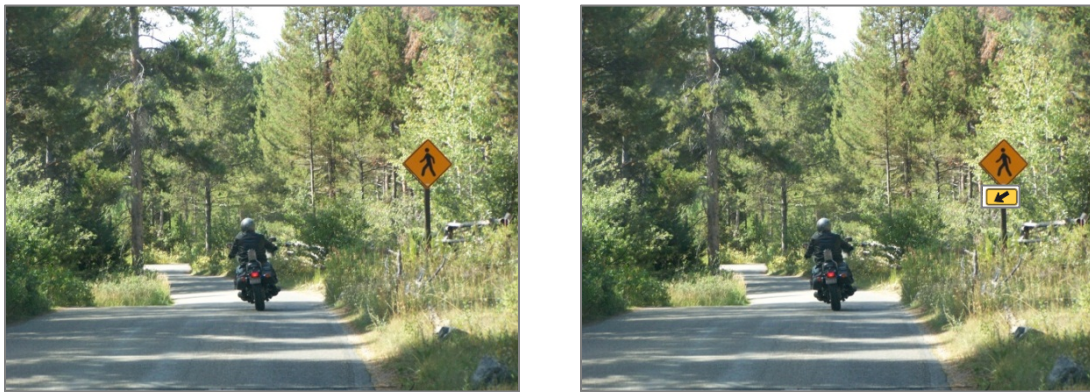
Figure 18. Pedestrian Crossing Sign: Existing (left), Proposed (right)

(Existing sign on right, proposed signing on left)

Ensure signs are at the proper mounting height and are located where they're not blocked by vegetation or other road features in order to improve driver response. For example, the location of the pedestrian warning signs at the trail crossings south of the LSR Preserve should have a diagonal down arrow (Figure 18) if they will stay at the crossing, or they could be moved away from the crossings to provide advance warning of the upcoming crossing (MUTCD 2C.50). Adjusting the location or adding additional advance warning signs will provide drivers more time to react if there are pedestrians at the crossing.

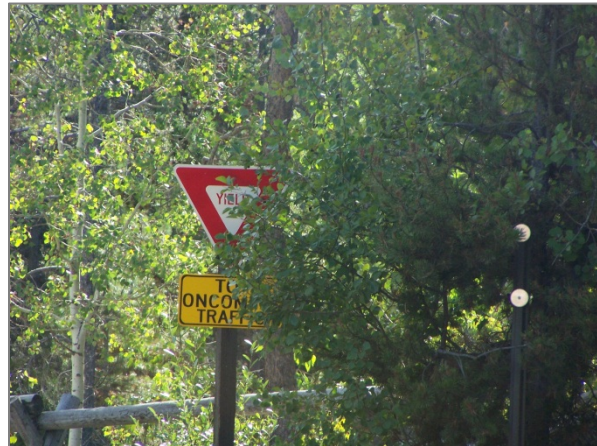
Figure 19. Sign Blocked by Vegetation

- Roadside Vegetation Maintenance –**
 Selective brushing could improve the visibility of warning and guide signs, along with increasing the sight distance for approaching vehicles. Roadside vegetation grows close to the edge of traveled way and can block signs and sight distance around horizontal and vertical curves, which can adversely affect motorist response time and action.

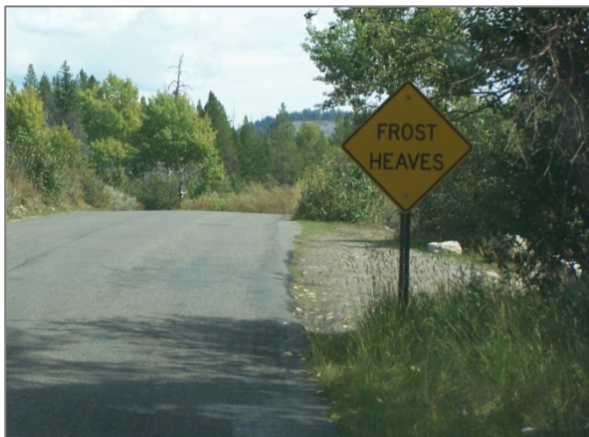
Figure 20. Unclear Sign Message

message or be understandable by travelers. An existing sign which may be confusing to the public is FROST HEAVES which some might expect to encounter during the winter, rather than when they appear during the spring. Another example is the ROUGH ROAD sign placed before the unpaved section instead of a PAVEMENT ENDS sign, as these messages may have different meanings for different drivers.

Evaluate sign messages to be consistent throughout the corridor and to also be pertinent to the purpose of the signs. Bike, pedestrian and equestrian signage could be improved in several ways: 1) to alert motorists to the presence of these non-motorized users along the entire corridor, and 2) to alert motorists prior to specific crossing locations. In addition, warning sign messages may not accurately reflect the purpose of the

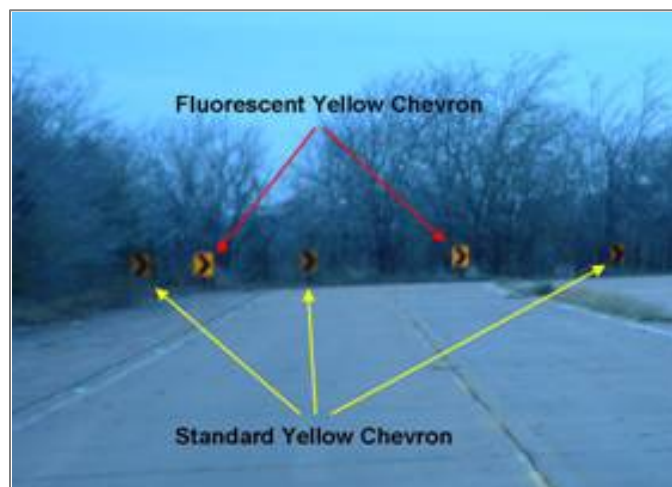
Figure 21. Standard Yellow Sheeting vs. Fluorescent Yellow Sheeting

When replacing signs according to a sign replacement plan, the retroreflectivity of the sign should also be addressed so that the signs are visible at night and in low light conditions. Since the Moose-Wilson Road runs through some forested areas with heavy shadows, retroreflective fluorescent sheeting would improve the visibility of signs that provide

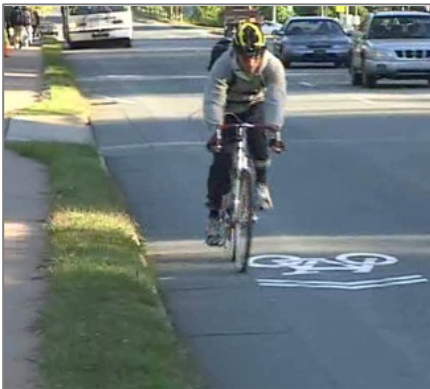
Figure 22. Example of a Sharrow

Evaluate the use of center lines, edge lines, crosswalk markings at trail crossings, and intersections markings per the requirements and recommendation in the MUTCD. Even though traffic volumes on Moose-Wilson Road may not meet MUTCD warrants, strategic use of pavement markings should be considered in the paved sections of the road to improve awareness of pedestrian crossings and aid in negotiating through intersections. The current trail crossings lack well-defined pavement markings that could highlight the actual crossing better than the stone-bordered colored concrete that currently exists. Visitors going through the Death Canyon Road intersection face a large paved area which is devoid of pavement markings to indicate which direction goes to Moose or Teton Village or Death Canyon, or where they should be driving when crossing the intersection. Consider the use of shared lane markings or “sharrows” (Figure 22) to alert motorists of the presence of cyclists, which may be especially beneficial on the uphill grades where slow cyclists may be present.

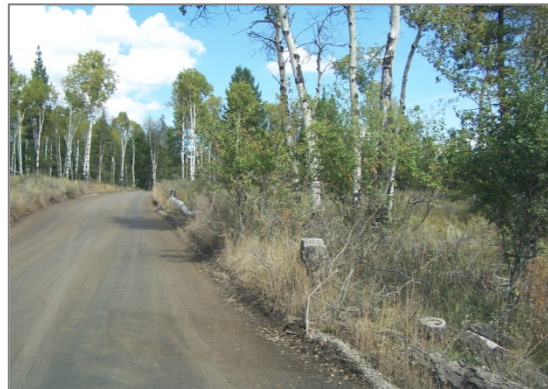
Figure 23. Stumps along Roadside

Remove stumps remaining from dead or downed trees, which are close to the edge of the road, especially in the unpaved section (Figure 23). These stumps, varying in diameter from about 4-inches to more than a foot across and heights up to 10-inches, pose a roadside hazard for motorists and bicyclists. According to the American Association of State Highway and Transportation Officials (AASHTO) Roadside Design Guide a vertical object of more than 4-inches can be a snagging hazard to vehicles that leave the roadway, and could cause an errant cyclist to go over their handlebars. A routine maintenance plan should be developed to address cutting dead or downed trees flush with the ground and provide guidance on when the stumps should be removed.

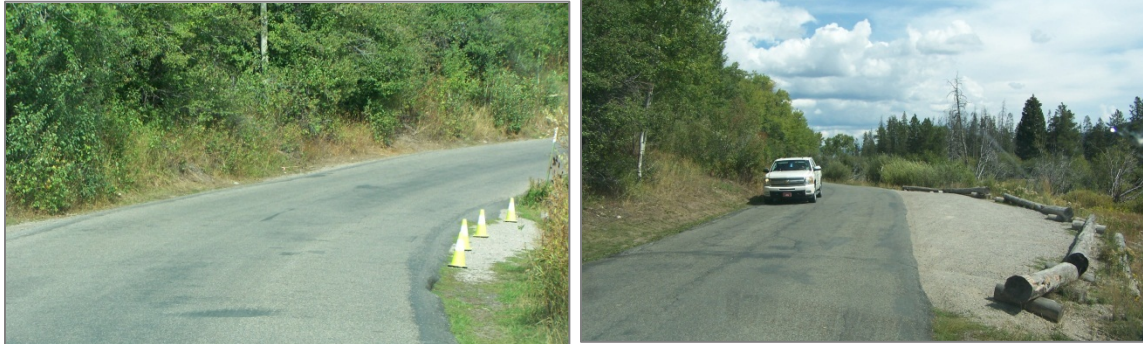
pullouts serve various needs, including wildlife viewing, turnaround locations, and wayfinding stops. The Park has been managing pullouts by placing cones, logs, or other landscaping material where parking is not desired due to resource or safety concerns.

Figure 24. Pullouts: User Created (on left) and Designated (on right)

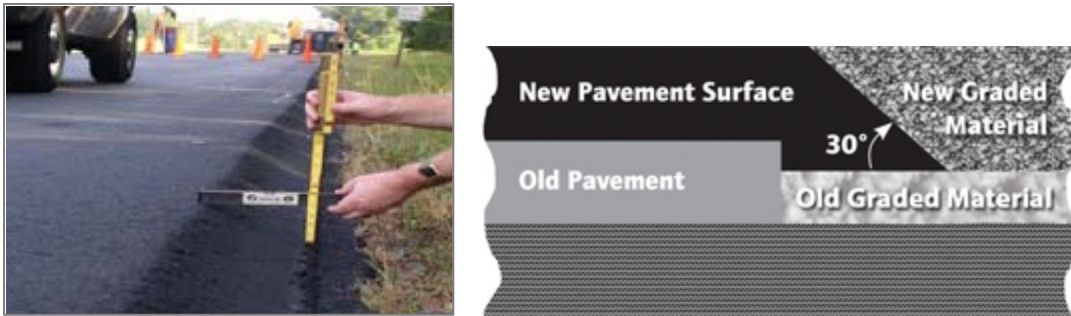
Figure 25. Safety Edge_{SM}

Address edge drop-offs and raveling pavement edges during future road improvements through the incorporation of the Safety Edge_{SM}.¹² The Safety Edge_{SM} provides a consolidated 30-degree wedge of asphalt which will not ravel or become a vertical edge drop-off. The wedge is then covered by shoulder material as shown on the right in Figure 25. This would improve the edge of the pavement and allow errant vehicles (motorized and non-motorized) to safely return to the road.

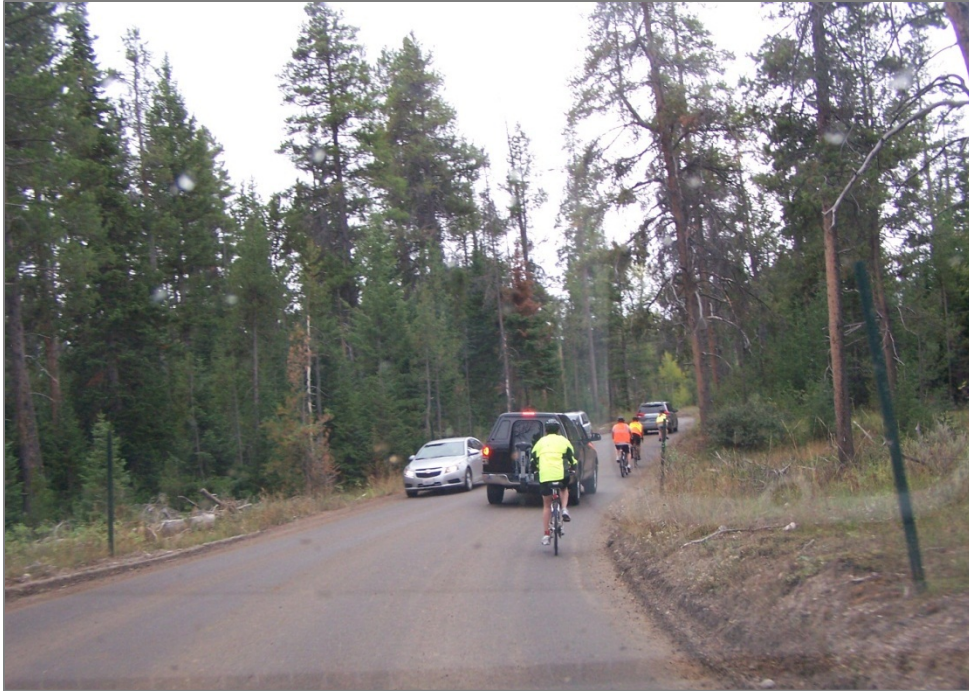
Figure 26. Variety of Travel Modes

It is assumed bicycle presence in the Moose-Wilson Road corridor will continue to increase as the local pathways are expanded and improved. To help improve the cycling experience in this corridor there are several options the Park could consider in future planning efforts, including: a separated (bike) pathway for all or part of the route; a one-way route (for north-to-south or south-to-north traffic) or a one-way couplet (a pair of one-way roads serving the same traffic corridor and performing as a divided facility) for all or part of the route; and a transit only route with a bike lane. While these suggestions are beyond the scope of what's generally considered in an "existing conditions" RSA, they are items the RSA Team encourages the Park to consider when evaluating other improvements to the Moose-Wilson Road during future corridor planning efforts as they can help improve safety for all users.
